WSCAM Inspection and Asset Maintenance Plan

Dampier Cargo Wharf

Reference No. 3006387-DCW-RPT-MAR-001

Prepared for Pilbara Ports Authority

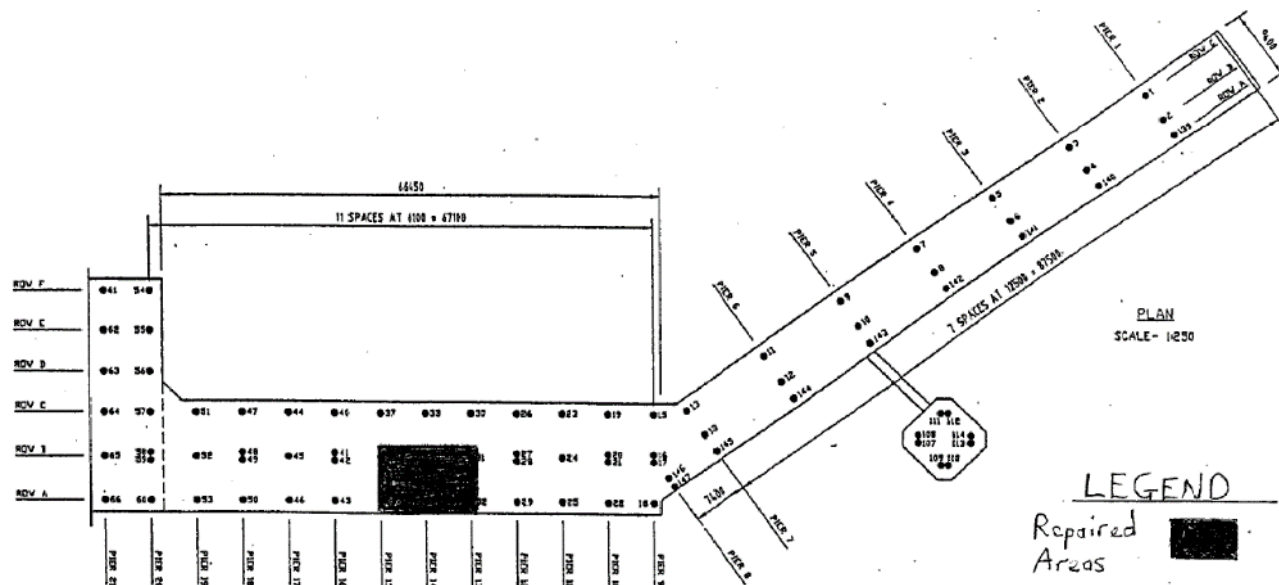
Figure 3: BMC repair area map (2005) showing repairs in Berth 7

In addition, Savcor indicated it had repaired 66% of the soffit of the original deck in the time, between the above repairs. This indicates that corrosion is occurring on the reinforcing steel between repair instances and that the previous repair methods are not dealing with the underlying corrosion problem.

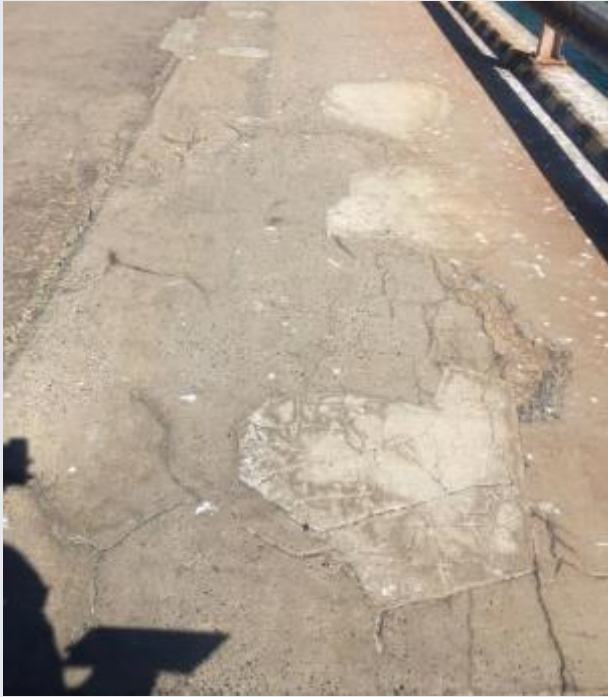
Site Observation	Image
Approach Bridge	
<p>The Approach Bridge concrete top surface had several localised spalls and delamination. Some concrete spalls appeared to have been repaired in the past, however, they have subsequently failed. Spalls are typically located on the deck joint edges.</p>

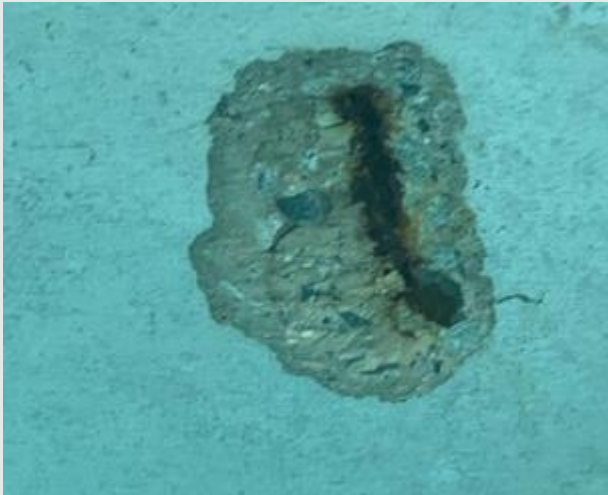
<p>The Approach Bridge prestressed beam soffit had several localised minor spalls. These areas were not accessible for close inspection from the boat.</p> <p>Visual estimation and drumminess testing indicated concrete delamination and spalls to be 200mm x 200mm. One location of spalling with exposed corroded reinforcement recorded in section DS_AC6/7. Two locations of spalling with exposed corroded reinforcement was recorded in section DS_AC7/8.</p> <p>Areas of previous repair were identified and indicate that corrosion has been significant in the past.</p> <p>One beam in section DS_AC5/6 and three beams in section DS_AC7/8 appears to be at a different elevation to other beams. This could potentially be sag or just dimensional variation between beams during construction.</p>

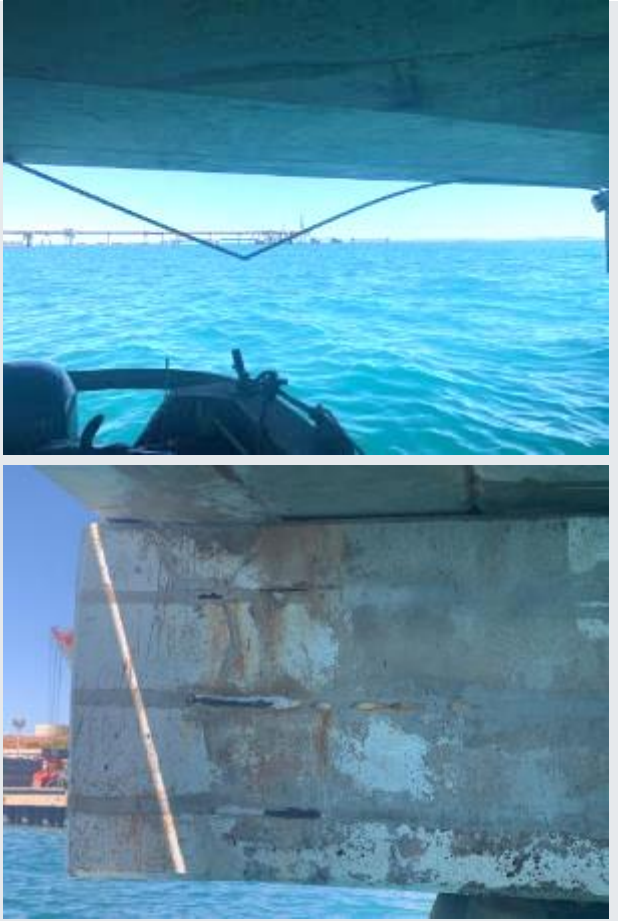
<p>The Approach Bridge prestressed beam eastern edge has had extension crack repairs by crack injection. The western edge has cracking and will require a similar repair.</p>	 
<p>The Approach Bridge Pier Headstocks had signs of cracking, honeycombing and reinforcement corrosion to most of the headstocks.</p> <p>Honeycombing was most apparent on the lower edges of the headstocks.</p> <p>Cracking is typically apparent at the headstock centre, at the joint.</p> <p>Impressed current cable and conduit on northern side is damaged on the south side of the headstock and damage and sagging on the north side of the headstock (attached to span DS_AC8/9). The impressed current cathodic protection (CP) to the headstocks of the Approach Bridge shows significant acid attack with characteristic brown staining near anodes and anodes being exposed in some locations.</p>

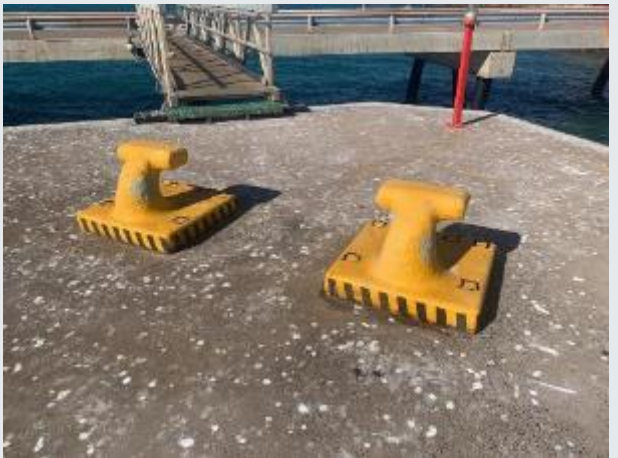
Southern Mooring Dolphin	
<p>The majority of the Southern Mooring Dolphin deck top surface was covered by bird droppings. No significant visual defects were observed.</p>

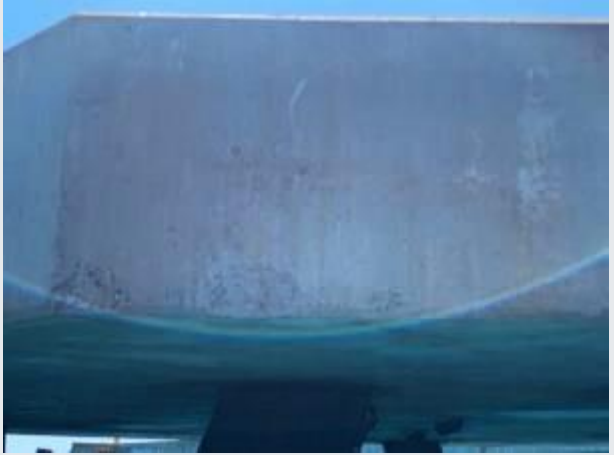
Site Observation	Image
<p>The Southern Mooring Dolphin had apparent signs of edge spalling around the south west corner. No signs of reinforcement or corrosion.</p>

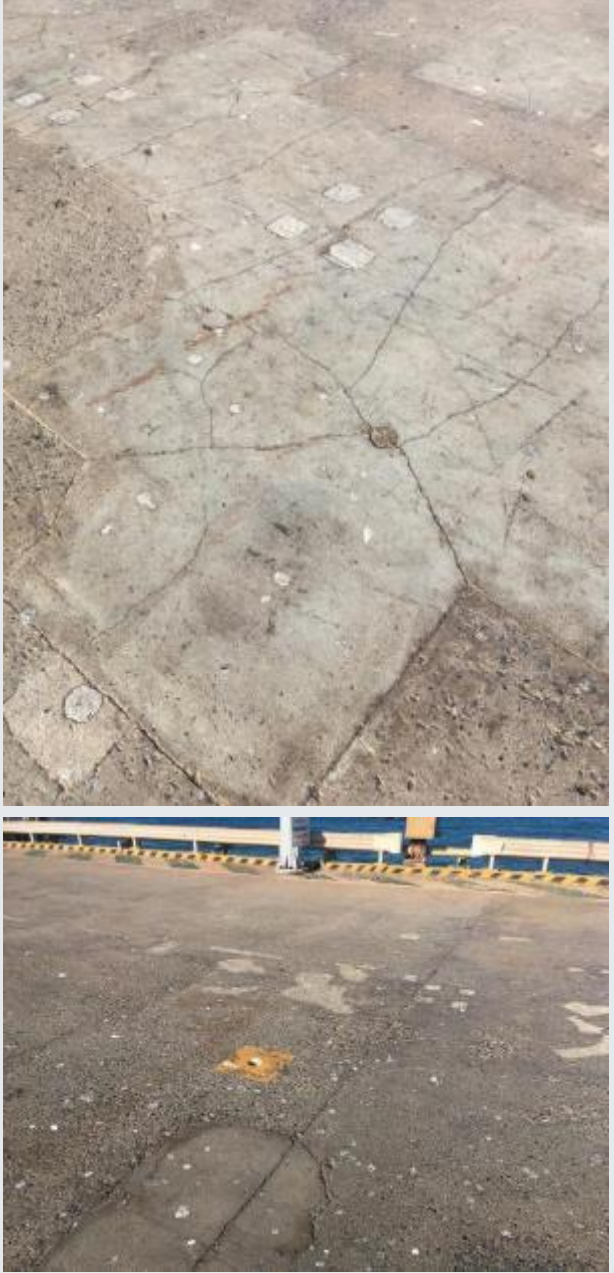
Original Wharf Structure	
<p>The Original Wharf in-situ deck top surface had localised concrete spalls, mostly near construction joints and past repairs.</p> <p>These defects are likely due to heavy vehicle impact at the uneven surface, or repair failure.</p>

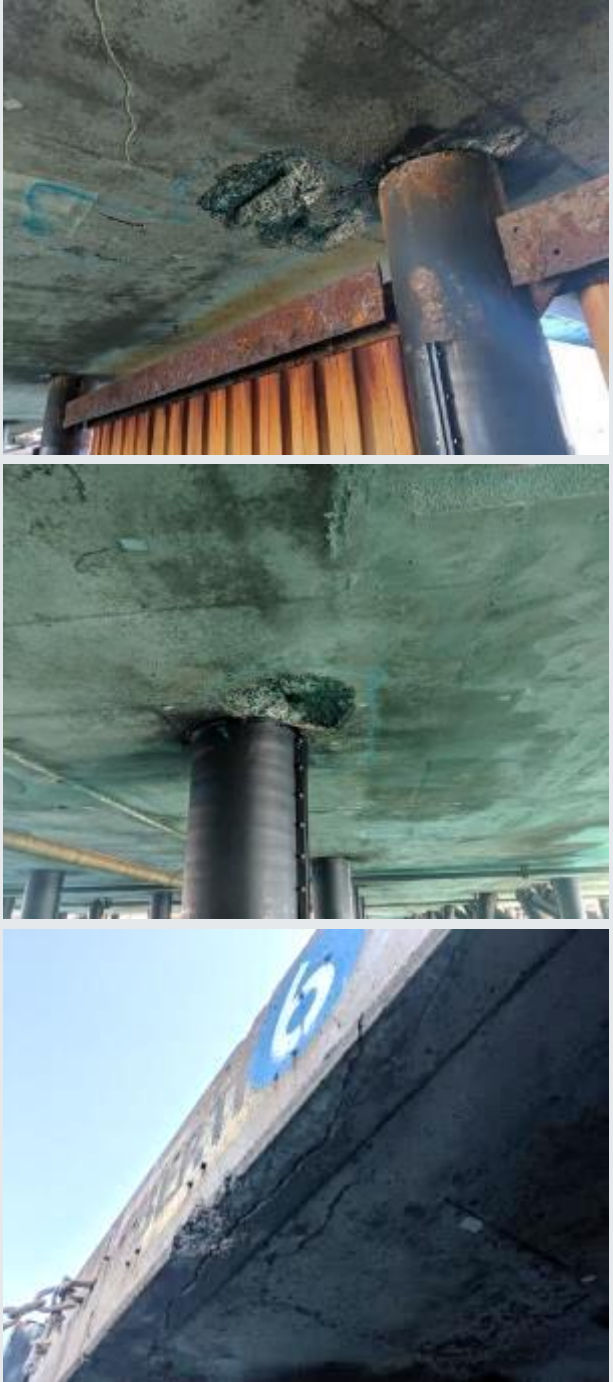
Site Observation	Image
<p>The Original Wharf deck soffit had visible localised delamination and spalling at multiple locations.</p> <p>The majority of defects were observed on the eastern edge or along the central grid E to F and several delamination spots have been marked out.</p> <p>Multiple localised spots of spalling with exposed corroded reinforcement was visible in sections DS_DF23/16, DS_DF24/28 and DS_FI21/24.</p> <p>There is severe concrete edge cracking (5mm in width), between Fenders F_I24 and F_I25.</p>

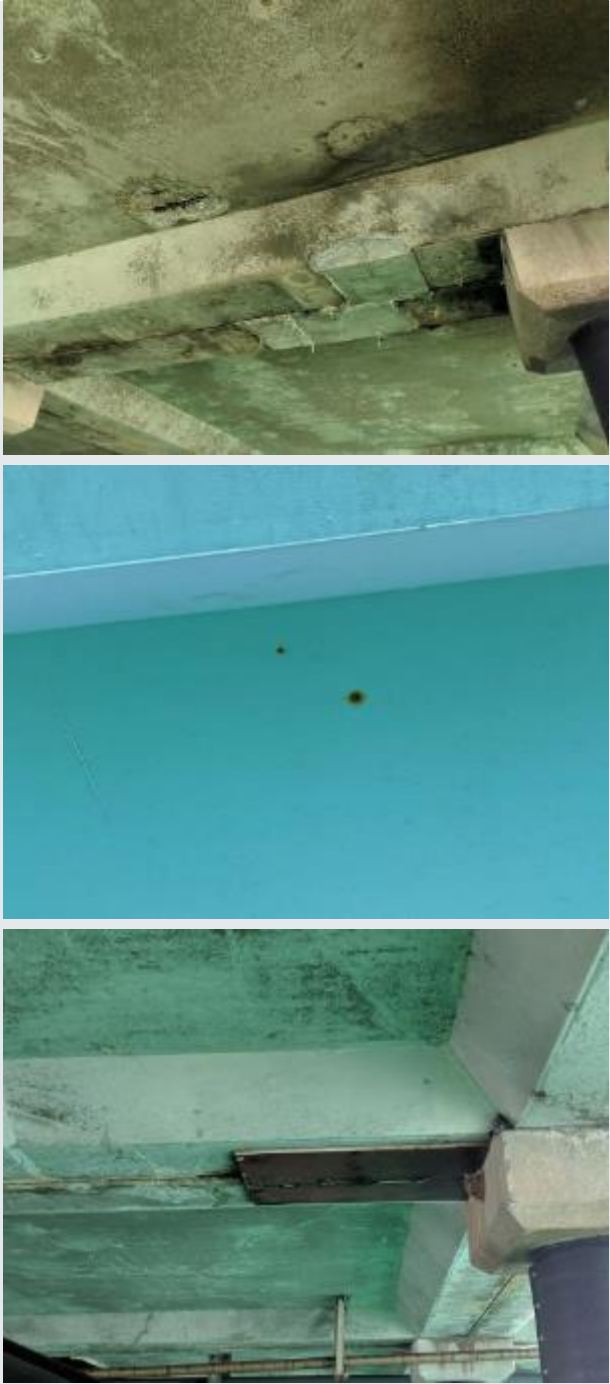
<p>The Extension Wharf deck soffit had multiple locations of localised delamination and spalling.</p> <p>There were many localised spalls with exposed corroded reinforcement occurring in most sections.</p> <p>Efflorescence has caused stalactite formation between piles P_J43 & P_K43 at repaired locations, with exposed corroded reinforcement on both sides.</p> <p>The new prestressed slab LM42/43 is showing signs of corrosion to reinforcement without signs of cracking to the deck soffit.</p> <p>Typically, there was spalling with exposed corroded reinforcement between the fender support frames on the eastern side. This defect has likely been initiated by ship impact onto the fender and then further deteriorated by chloride induced reinforcement corrosion.</p> <p>Repair has been noted near Pile P_K40, where the timber formwork has been left attached.</p>

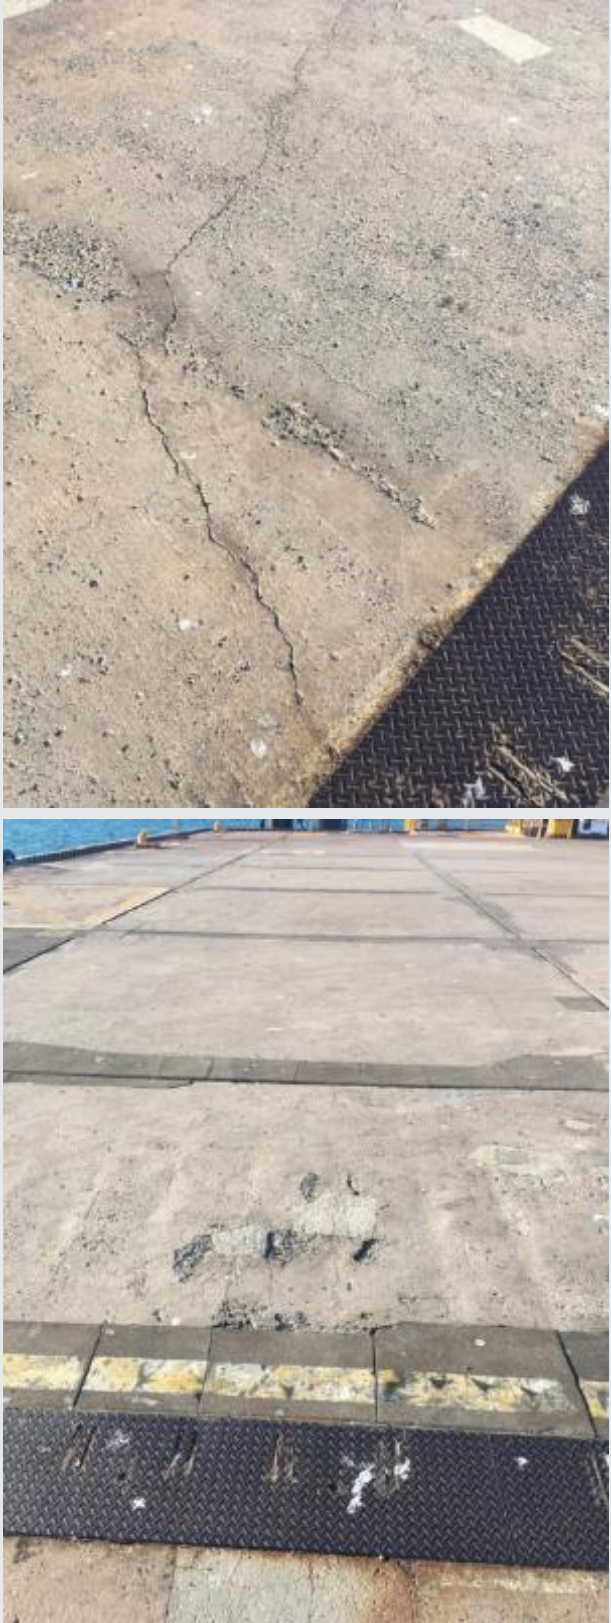
Site Observation	Image
<p data-bbox="164 208 336 230">Embedded Dolphin</p> <p data-bbox="164 253 746 320">Surface concrete spalling was observed around the edge of the Embedded Dolphin deck top. The deck top repair in 2009-2012 reinstated the precast panels adjacent to the embedded dolphin.</p> <p data-bbox="164 331 746 398">At some positions, crack widths of up to 0.6mm were measured which would allow water and chloride ingress to the surrounding concrete.</p> <p data-bbox="164 409 746 454">It is apparent that steel cover plates have been recently installed over the embedded dolphin edges.</p>

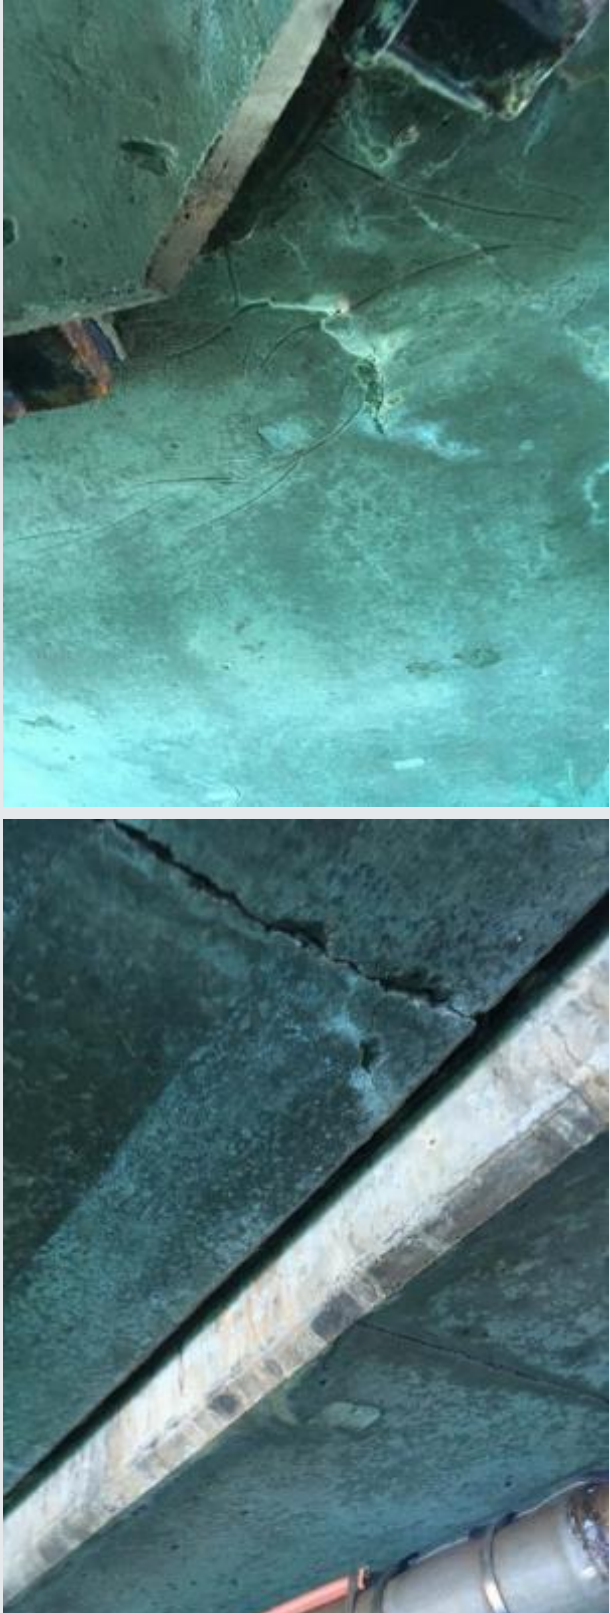
Site Observation	Image
<p>The Embedded Dolphin deck soffit had medium cracking and localised delamination on the eastern side.</p> <p>Minor corrosion was observed on the steel edges.</p>

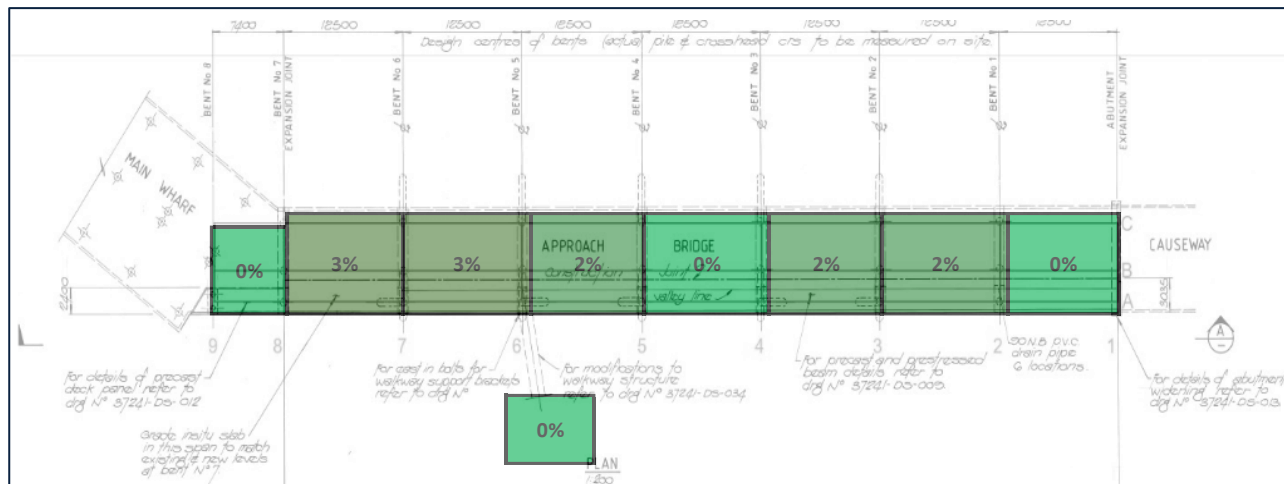
Figure 10: Delamination Survey of the Approach Bridge Deck Soffit

The deck was divided up into sections and a percentage surface area of delamination and spalling was recorded. Figure 10, Figure 11 and Figure 12 identifies the estimated percentage surface area of delamination and spalling recorded in each deck soffit section. Even though a delamination tool was used to test for drumminess in the concrete deck soffit, it is likely significantly more delamination and corrosion is present than that found in the survey. A full set of defect maps are presented in Appendix C

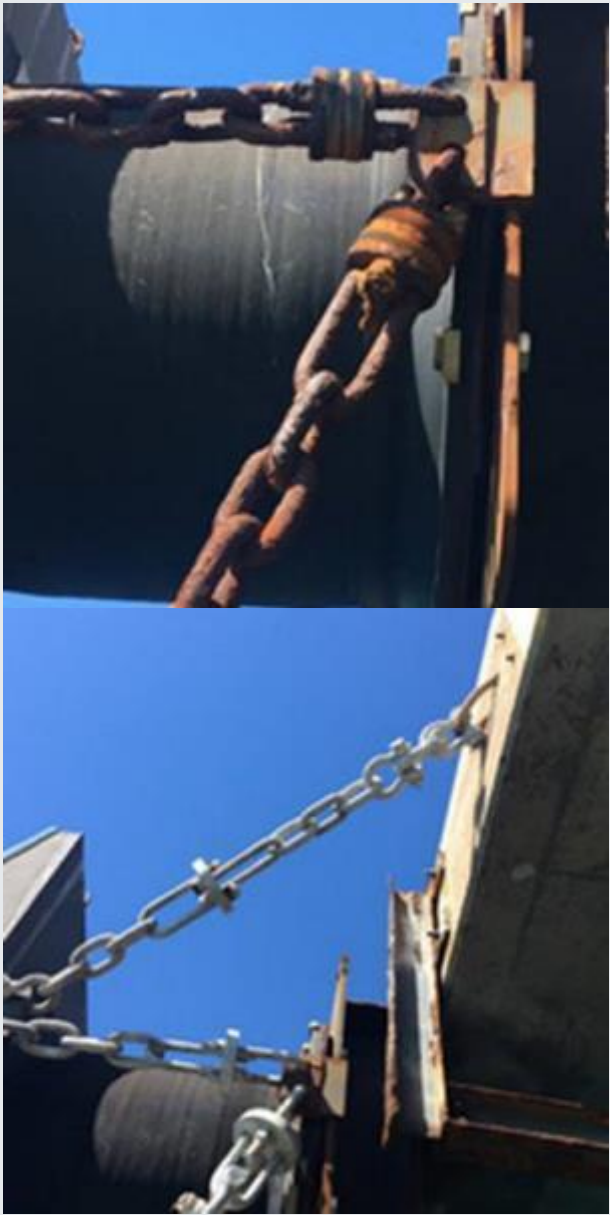
Site Observation	Image
<p>On chains that have not been replaced, heavy corrosion is present along with loss of section in chains.</p> <p>Wear to fender panels varies, all bolts and UHWPE panels are present (with the exception of one fender that is missing the whole panel).</p> <p>On Fender I25, new chains and a fender panel are present, but on the right-hand side the chain tensioner has insufficient thread protrusion. Multiple shackles have been used instead of correct length of chain.</p>

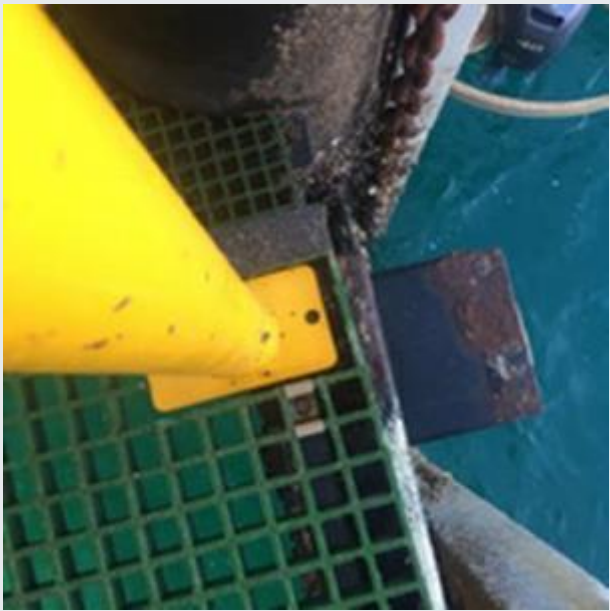
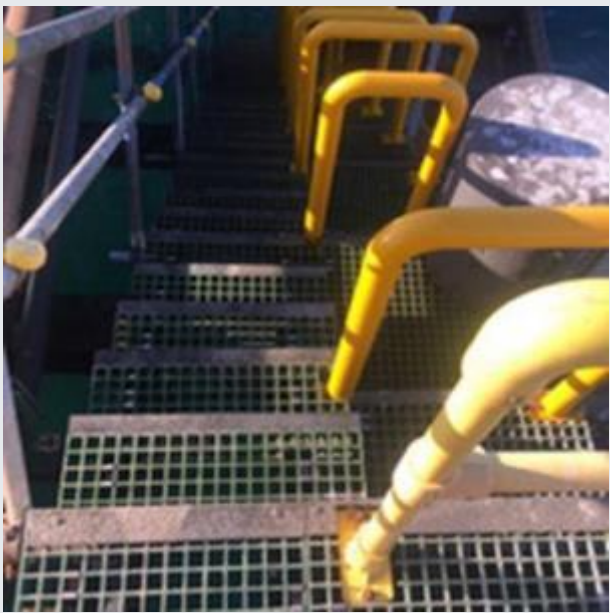
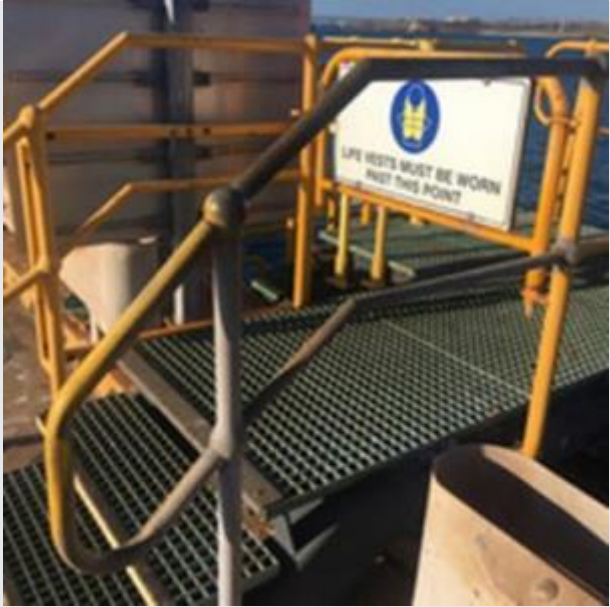
Site Observation	Image
<p>FRP and clips are in good condition and relatively new. Anti-slip tread is in good condition.</p> <p>Handrails on the eastern side are free of corrosion and recently replaced. Hold down bolts are dissimilar metal to the landing and rails and therefore, corrosion will potentially increase. Two bolts are already identified as not present. A review of the handrail connection detail is recommended.</p> <p>Handrails on the western side is made of scaffolding and is not tagged. Landing handrails are not compliant with AS 1657.</p> <p>Plastic handrails at the top of landing are damaged from UV exposure and susceptible to brittle failure. Replacement should be considered.</p> <p>One section of handrail is unpainted.</p> <p>No toe boards are present at the top of the landing as per AS 1657.</p> <p>Top of one fender panel is cracked with holding bolts corroded</p>

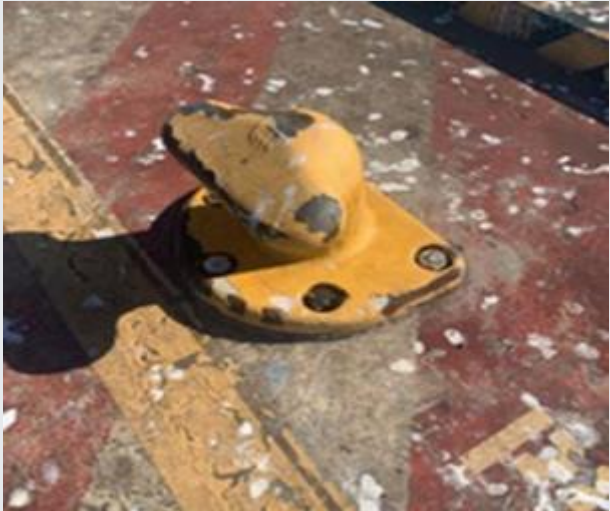
Site Observation	Image
<p>Corrosion is present on a large number of bollards.</p> <p>Repainting of corroded surfaces is recommended to prolong durability. On B7A, the paint has cracked and failed in large areas resulting in bare steel being visible. Surface corrosion with more advanced corrosion is visible.</p>

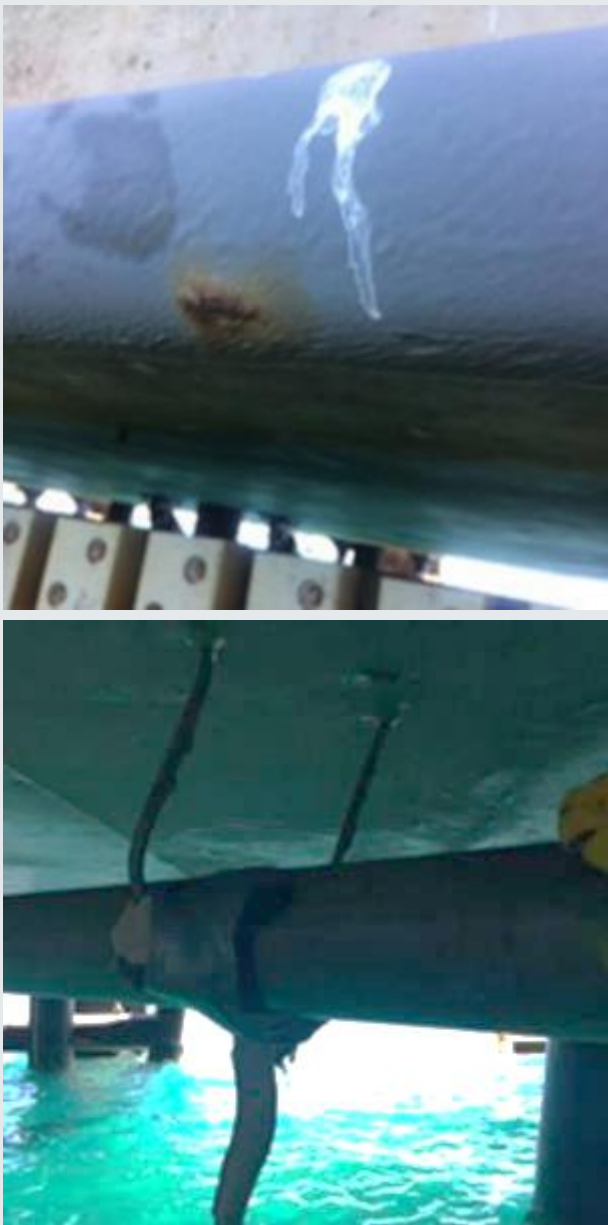
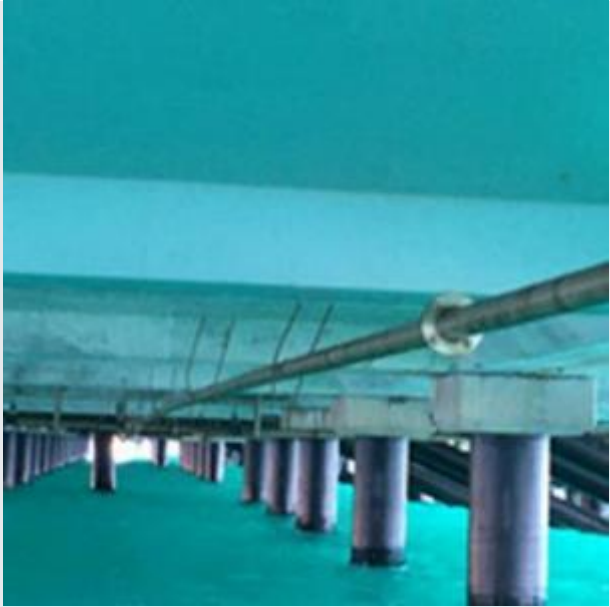
Site Observation	Image
<p>Water line:</p> <p>Stainless steel rods grouted/epoxied into soffit have deformed along length of water line</p> <p>Near abutment bracket is heavily corroded with protective paint covering less than 50% of the bracket. There is one missing bolt in a bracket on the approach bridge and stainless-steel ties are breaking due to corrosion. Duct tape used to secure some sections of pipe.</p> <p>Fuel line:</p> <p>Pipe supports on Berth 6 are heavily corroded and two pipe breaks are present in the line preventing supply to Berth 2 and the western side of the DCW.</p>
