Asbestos Removal Specification – A Block Flooring, Tuart College [4505]

Asbestos Removal Specification

Tuart College [4505]

Prepared For:	Programmed Facility Management 47 Burswood Rd Burswood WA 6100
Client Reference:	WA10419922
Report Number:	25-019.001
Version:	1.0
Date of Issue:	14 March 2025

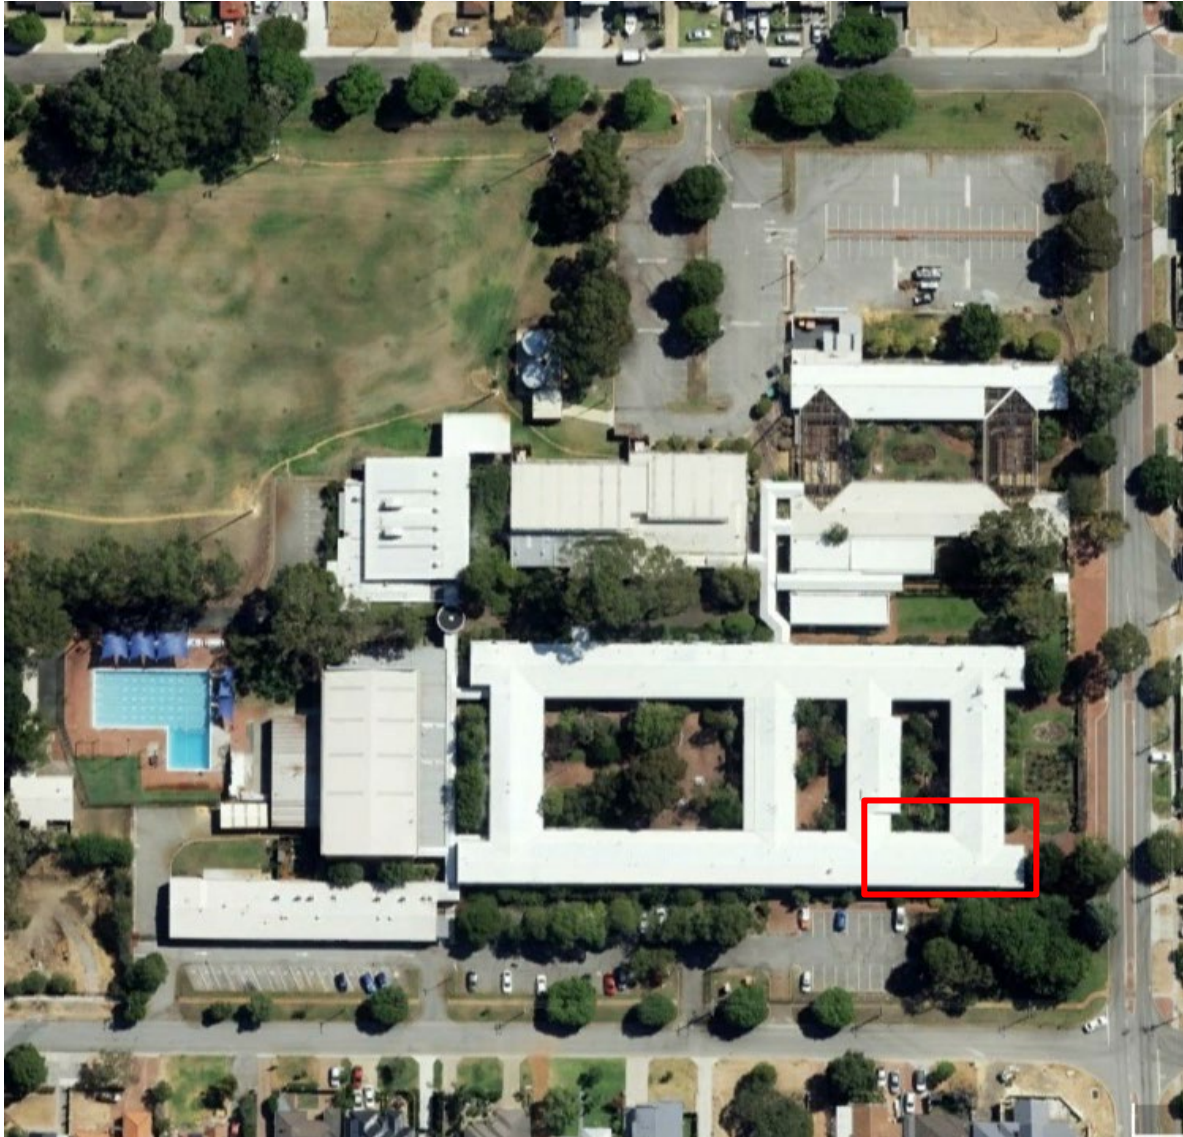
Figure 1: Site Plan

The red highlighted overlays in Figure 1 below detail the approximate location of the rooms on the first floor of the site that require remediation.

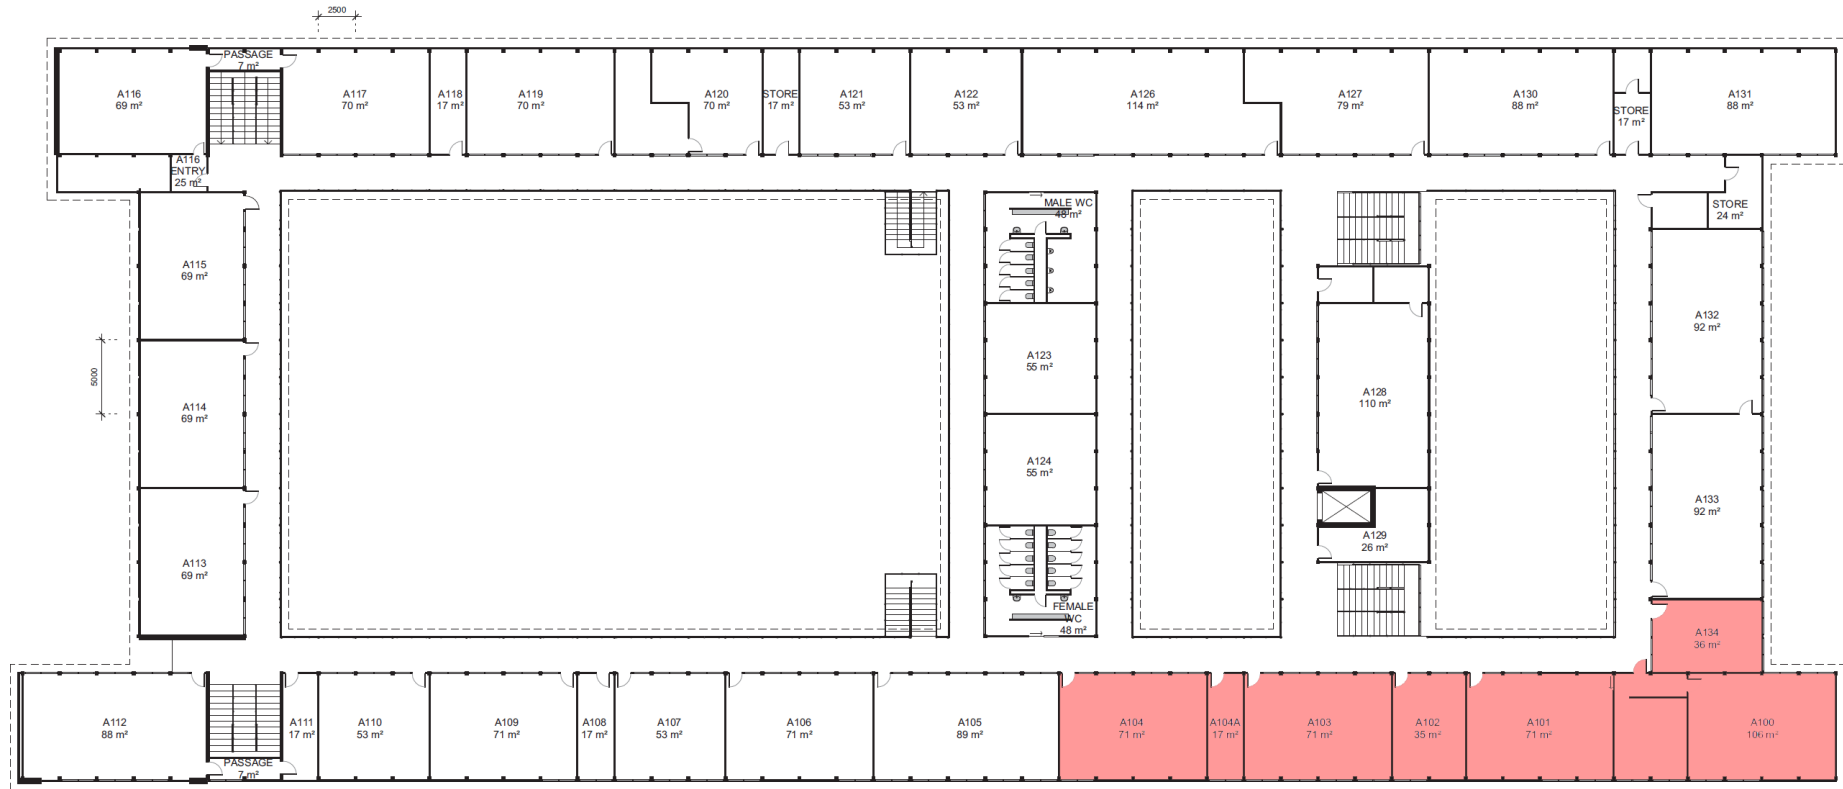
Figure 3: Building/Room Layout Plan

The highlighted areas in Fig.3 are those rooms with floor tiles identified as requiring removal.

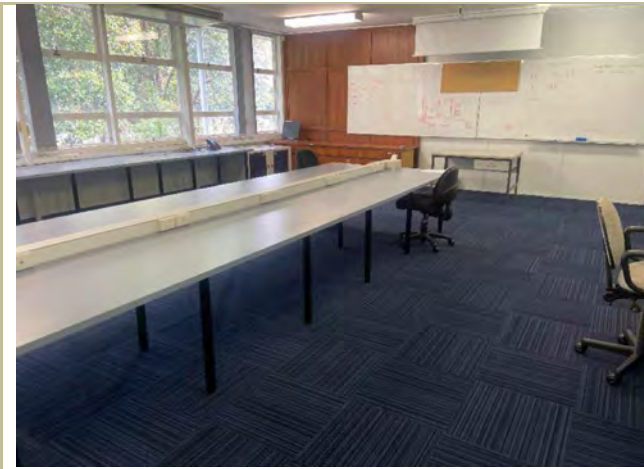
Item Number 1: Internal, L1, Beneath Carpet, west side, Vinyl Floor Tile and glue - Chrysotile

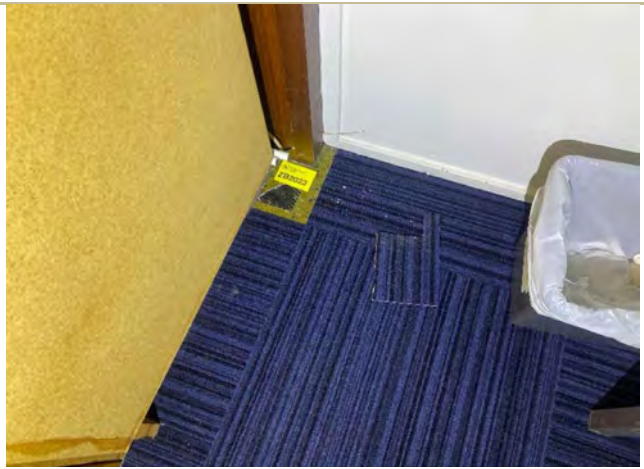
Item Number 1.1: Internal, L1, Beneath Carpet, west side, Vinyl Floor Tile and glue - Chrysotile

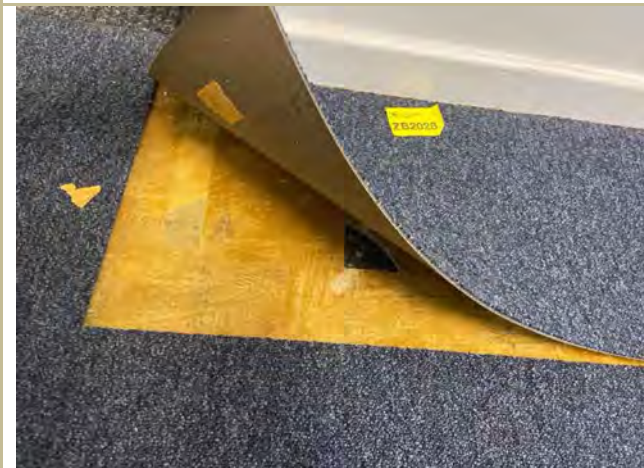
Item Number 2: Internal, L1, Beneath carpet, Northwest adjacent staff passage way, light blue tile, Vinyl Floor Tile and glue - Chrysotile

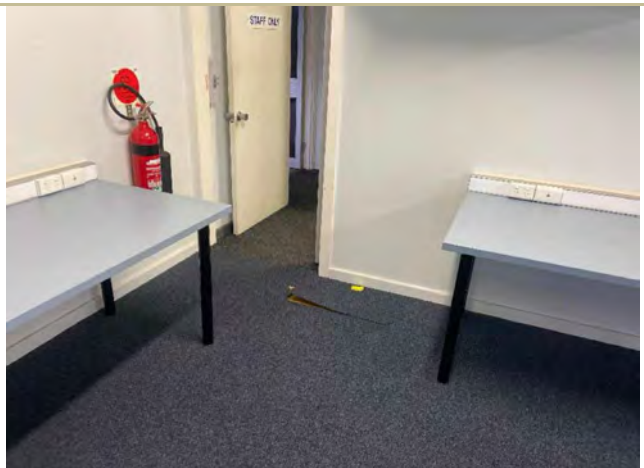
Item Number 2.1: Internal, L1, Beneath carpet, Northwest adjacent staff passage way, light blue tile, Vinyl Floor Tile and glue - Chrysotile

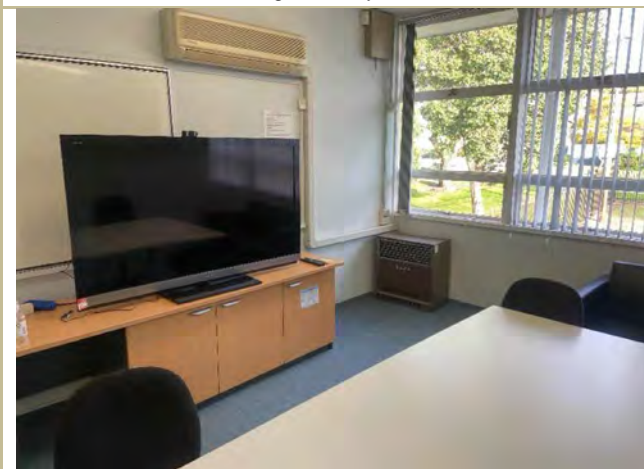
Item Number 3: Internal, L1, Beneath carpet, South East corner, Vinyl Floor Tile - Chrysotile

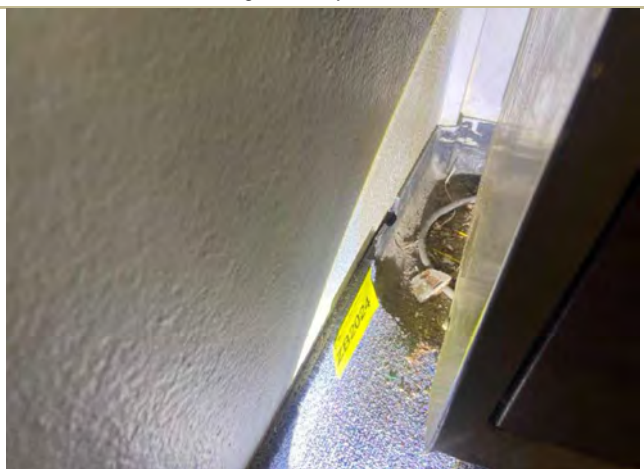
Item Number 3.1: Internal, L1, Beneath carpet, South East corner, Vinyl Floor Tile - Chrysotile

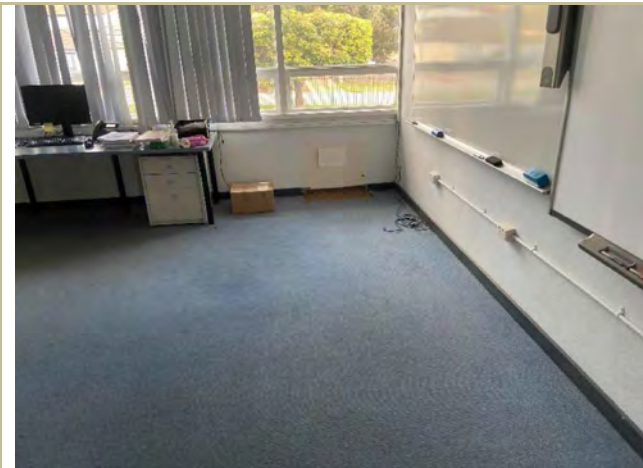
Item Number 4: Internal, L1, Beneath carpet, South elevation, light blue tile, Vinyl Floor Tile and glue - Chrysotile

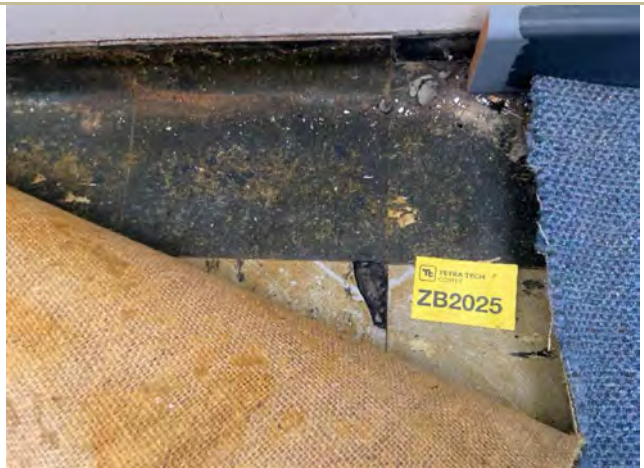
Item Number 4.1: Internal, L1, Beneath carpet, South elevation, light blue tile, Vinyl Floor Tile and glue - Chrysotile

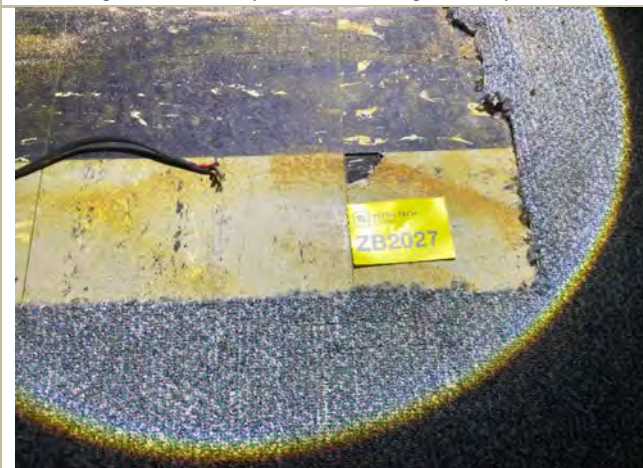
Item Number 5: Internal, L1, Beneath carpet cut out, south elevation, light grey tile and adhesive, Vinyl Floor Tile - Chrysotile

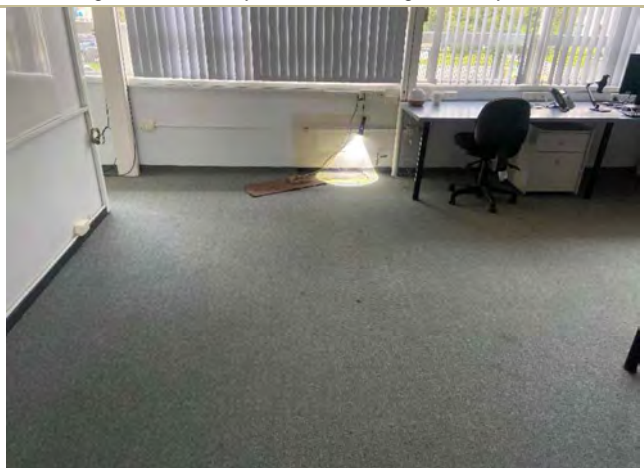
Item Number 5.1: Internal, L1, Beneath carpet cut out, south elevation, light grey tile and adhesive, Vinyl Floor Tile - Chrysotile

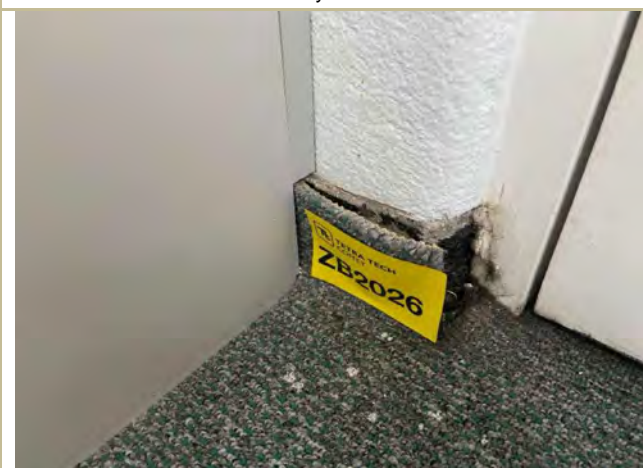
Item Number 6: Internal, L1, Beneath carpet, South elevation, Black tile, Vinyl Floor Tile - Chrysotile

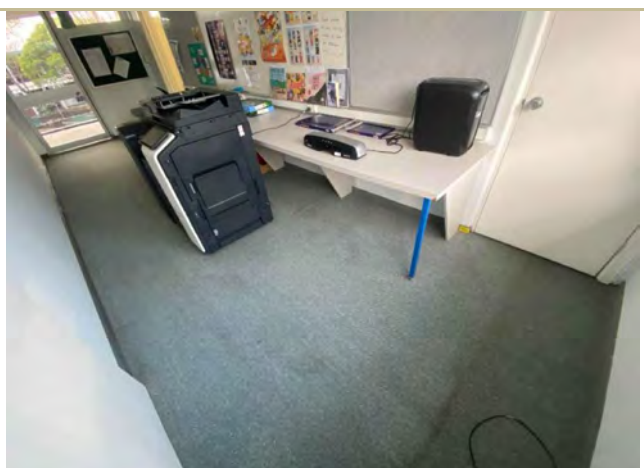
Item Number 6.1: Internal, L1, Beneath carpet, South elevation, Black tile, Vinyl Floor Tile - Chrysotile

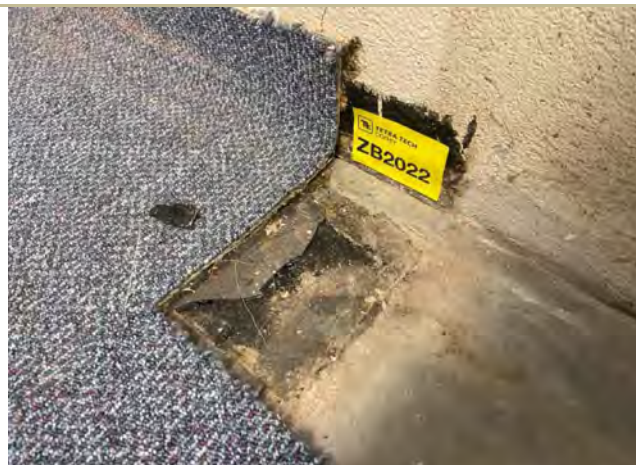
Item Number 7: Internal, L1, Beneath carpet, South East corner of room, Vinyl Floor Tile and glue - Chrysotile

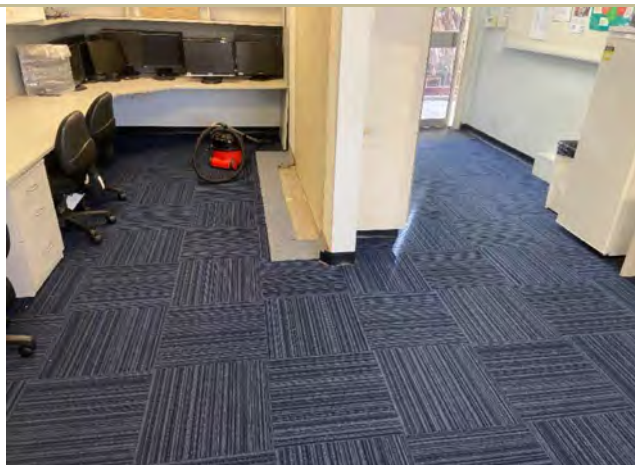
Item Number 7.1: Internal, L1, Beneath carpet, South East corner of room, Vinyl Floor Tile and glue - Chrysotile

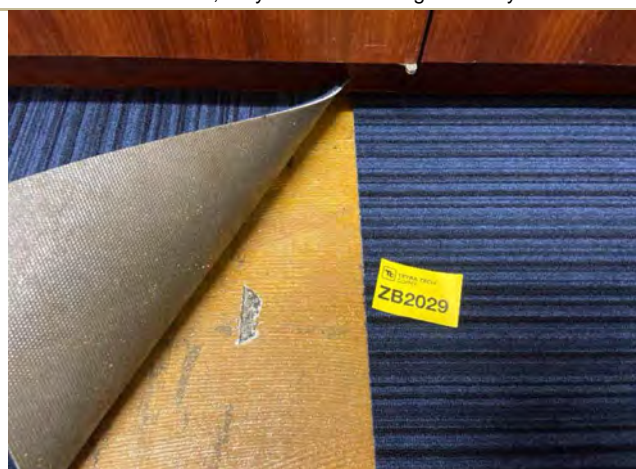
Item Number 8: Internal, L1, Admin office, central, beneath carpet, grey tile, Vinyl Floor Tile and adhesive - Chrysotile

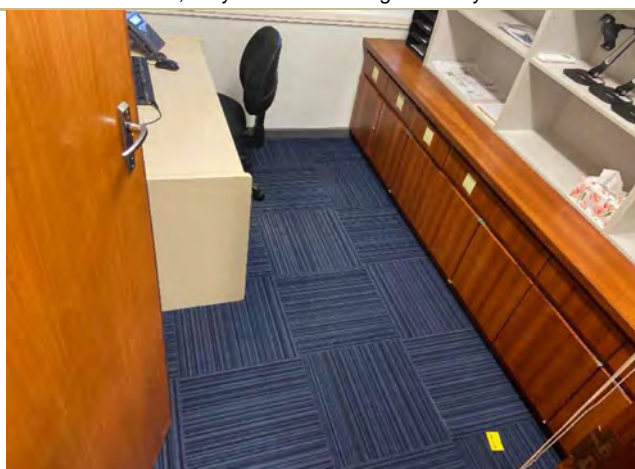
Item Number 8.1: Internal, L1, Admin office, central, beneath carpet, grey tile, Vinyl Floor Tile and adhesive - Chrysotile
