WSCAM Inspection and Asset Maintenance Plan

Dampier Cargo Wharf

Reference No. 3006387-DCW-RPT-MAR-001

Prepared for Pilbara Ports Authority

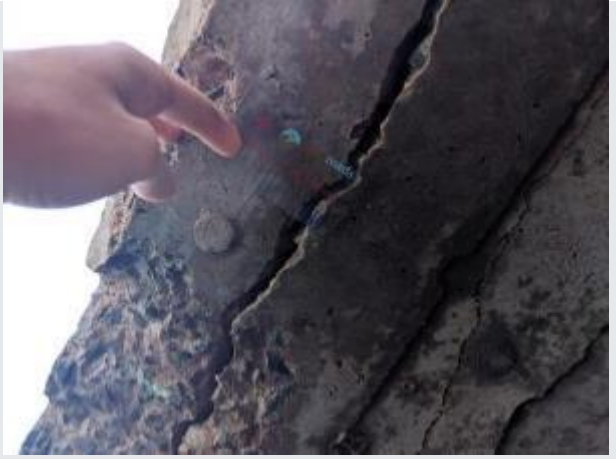
A close-up photograph showing a hand pointing to a crack in a concrete structure. The crack is dark and runs diagonally across the frame. The concrete surface is rough and weathered.
Extension Wharf Structure	
<p>The top surface of the Extension Wharf precast deck panel was generally in good condition, noting that the precast panel joint repairs were completed between 2009 and 2012. Cracking at the repaired panel edge was observed in most areas.</p> <p>It is understood that an epoxy-based grout material (BASD Masterflow 648) was used for the panel edge repair works conducted between 2009 and 2012 with the intention to resist high impact loads from vehicles. However, deformation of the epoxy repair under high applied wheel loads might have resulted in overstressing of the peripheral bond lines, causing visible peripheral cracks.</p> <p>Cracking at the repaired panel edge was observed in most areas. Multiple areas of localised spalls and delamination were observed.</p>

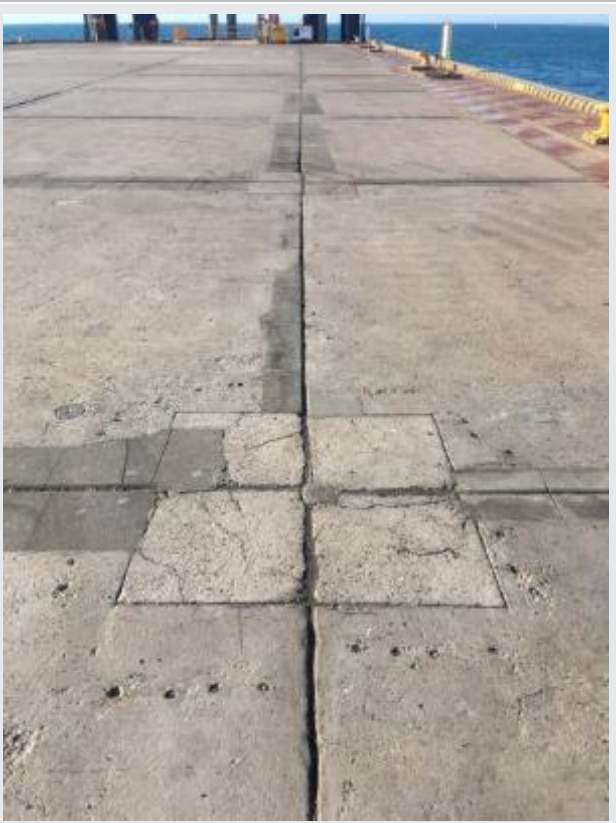
A photograph of the Extension Wharf precast deck panel. The panel is made of concrete and shows significant cracking and spalling. The cracks are visible along the edges and across the surface. The spalls are areas where the concrete has broken away, revealing the underlying structure.

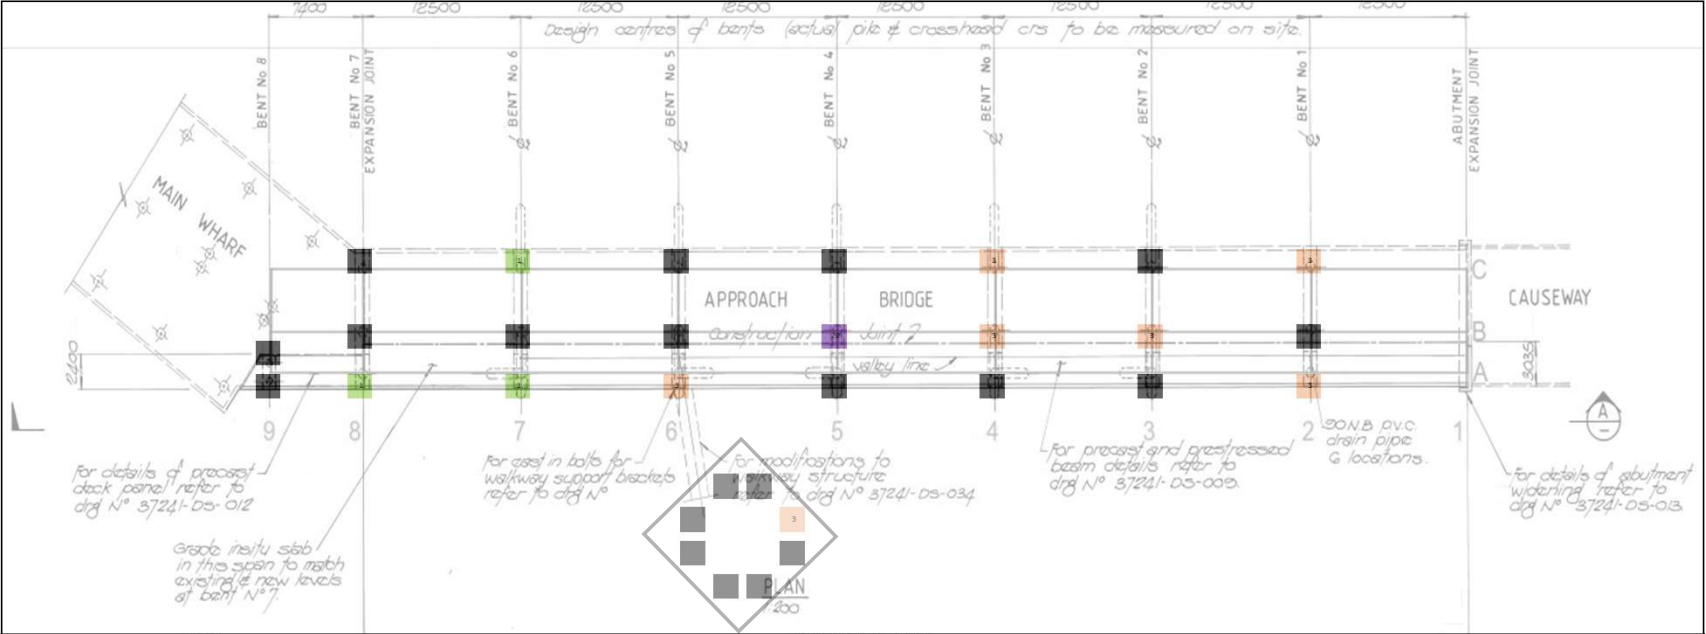
APPROACH BRIDGE

■	No defects observed
■	1. Jacket replaced
■	2. Jacket damaged or torn
■	3. Small punctures in jacket
■	4. Bulging in jacket
■	5. Corrosion due to missing jacket sections
■	6. Missing bolt in jacket
■	7. Pitting in pile. No signs of corrosion
■	8. Minor corrosion to pile noted during dive inspection
■	9. Jacket is weathered
■	20. Items 4, 6 and 7
■	21. Items 3 and 4
■	22. Items 4 and 5
■	23. Items 1 and 5
■	24. Items 2 and 3
